# CONSULTING SERVICES FOR THE ASSESSMENT AND DESIGN OF FUNCTIONAL ELEMENTS OF PUBLIC-SCHOOL BUILDINGS SELECTED FOR RETROFITTING AND STRENGTHENING/UPGRADING IN PREPARATION FOR "THE BIG ONE"

UNDER IBRD LOAN NO. 9251-PH: PHILIPPINES SEISMIC RISK REDUCTION AND RESILIENCE PROJECT

# **ENVIRONMENTAL AND SOCIAL MANAGEMENT PLAN (ESMP)**

(STA. LUCIA HIGH SCHOOL)

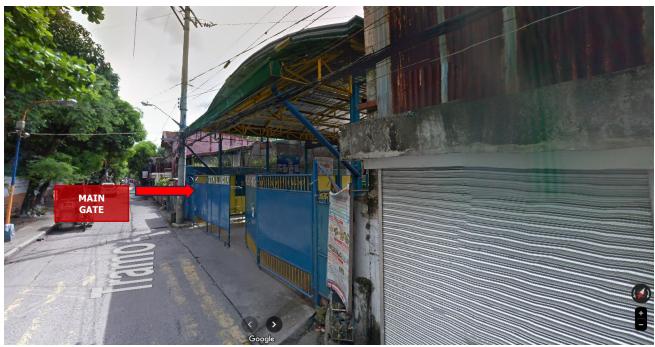
Figure 1-1: Access to Sta. Lucia High School

Sta. Lucia High School is accessible via the road network consisting of Ortigas Avenue Ext, Bonifacio Avenue, Cardinal Santos, Sapphire St., St. Martin St., Parola St., and Tramo Street. The road directly in front of the school, Tramo Street, is approximately five meters wide and features two lanes (see **Figure 1-1**).

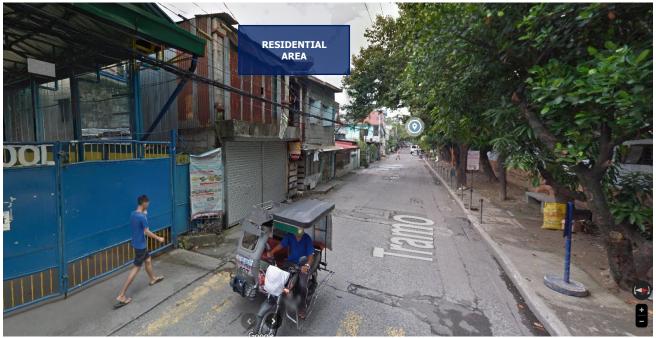
Figure 1-2: Vicinity of Sta. Lucia High School

Sta. Lucia High School is under institutional use and is surrounded by residential areas based on the Comprehensive Land Use Map of Pasig City. The school site has only one main gate in which learners and school personnel can enter and exit. The main gate measures 9 meters wide.

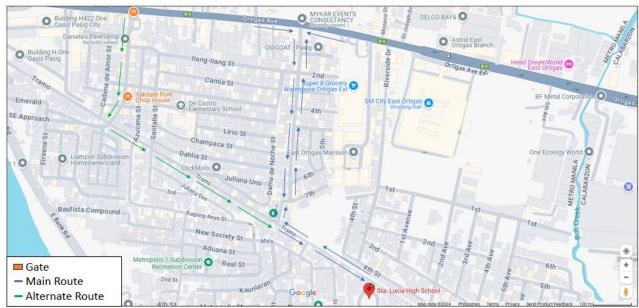
Figure 1-3: Proposed Delivery Route for the Project

The proposed delivery route for the project is illustrated in **Figure 1-3**. It is a multiple-way route starting at Ortigas Ave, turning right or left into Countryside Ave. The delivery vehicles will travel approximately 530 meters before turning left into Tramo Street, where the school is located. The same route will be traversed by the vehicles after its delivery. An alternative route is via Ortigas Ave, De Castro Ave, and Tramo Street. All roads along the proposed route are asphalt paved.

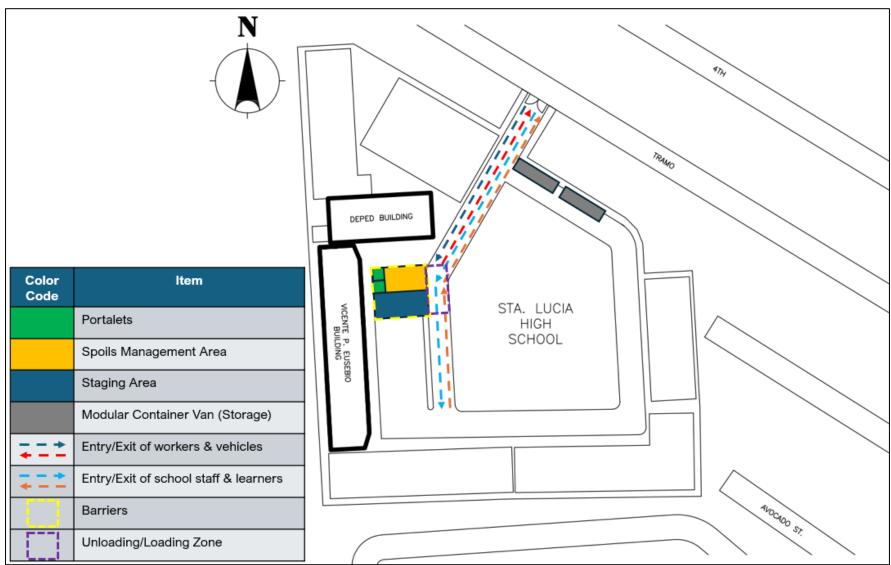
Figure 1-4: Proposed Staging Area and other Support Facilities in Sta. Lucia High School

A staging area serves as the temporary place for storing construction material and equipment to ensure safety, efficiency, and cost-effectiveness throughout the construction process. Based on the consultations with the school, the proposed staging area and other support facilities (i.e., sanitation facility, spoil management) will be placed in front of Vicente P. Eusebio Building and DepEd Building.

In addition, container vans will be placed along the road in front of the bulletin board area within the school. These will serve as temporary storage area of the school materials.
